This is not a warning about a problem with [Milk Paint](#). The purpose of this article is to alert the users of milk paint to avoid Minwax Color-Changing Wood Filler. As currently formulated, this stuff will have disastrous consequences on your finish and my well destroy all the hard work you have put into your project. Read on and I will explain...

Milk Paint Users Beware!

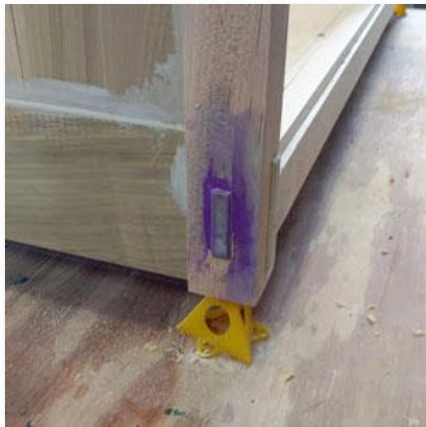
Well, as you can see in the photo, things soon went very badly. What on earth (I edited that just a bit) is going on? Is my brush contaminated? Was there something in the container used to mix the milk paint? If I hurry

can I wipe it off? No, No and NO! Whatever has caused this ugly stain, it is here to stay! But what is it and what is its cause?

In short order I realized that the stain was associated with one of the mortise-and-tenon joints to which I applied filler. But the size of this purple blob is infinitely larger than the tiny area I filled. It can't possibly be the filler, can it? It's time to set aside finishing my custom piece and do some testing. This is no time to move forward and only make matters worse.

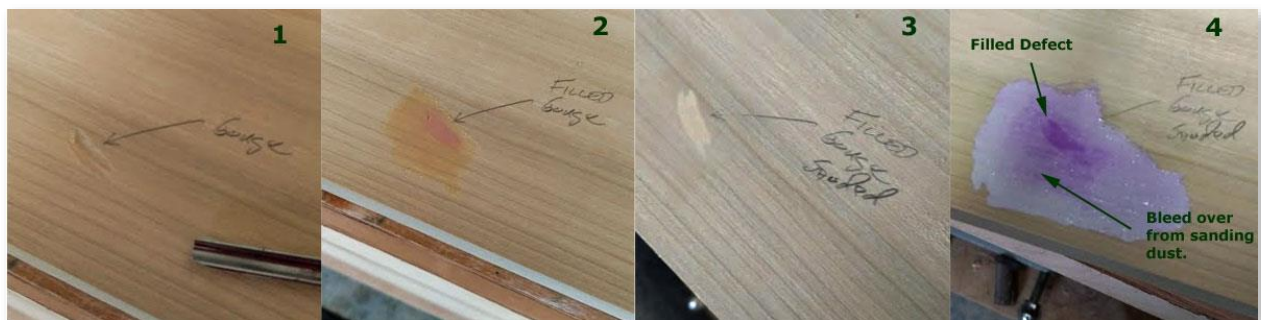
1. Created a test defect,
2. Applied the suspect filler,
3. Sanded the filler when dry, and
4. Applied milk paint to the filled area.

The Minwax Color-Changing Wood Filler is clearly the problem...

As the photos attest, the filler is the problem. The stain in the milk paint is obviously related to the *Minwax Color-Changing Wood Filler*. But why is the area of the stain so much larger than the area of the defect that was filled? The filler was only applied to the small defect I carved into the test board (photo 1). Yet the purple stain has expanded over an area several times larger than the defect (photo 4). Two observations are apparent:

1. First, the defect to which the filler was applied is clearly visible in photo 4. It is the darkest area of the stain and the shape perfectly defines the defect. This clearly points to the filler as the source of the stain.
2. Second, the spread of the stain to the area surrounding the filled defect can only be explained as resulting from sanding dust containing the filler being packed into the pores of the adjacent wood. The stain was not carried by my brush. It was produced when

the milk paint was applied to the filler, both the body of the filler in the defect and the filler dust created and spread over the area when the filled defect was sanded.

It should be apparent from this test that some component of the *Minwax Color-Changing Wood Filler* is reacting with the milk paint to produce this most undesirable result.

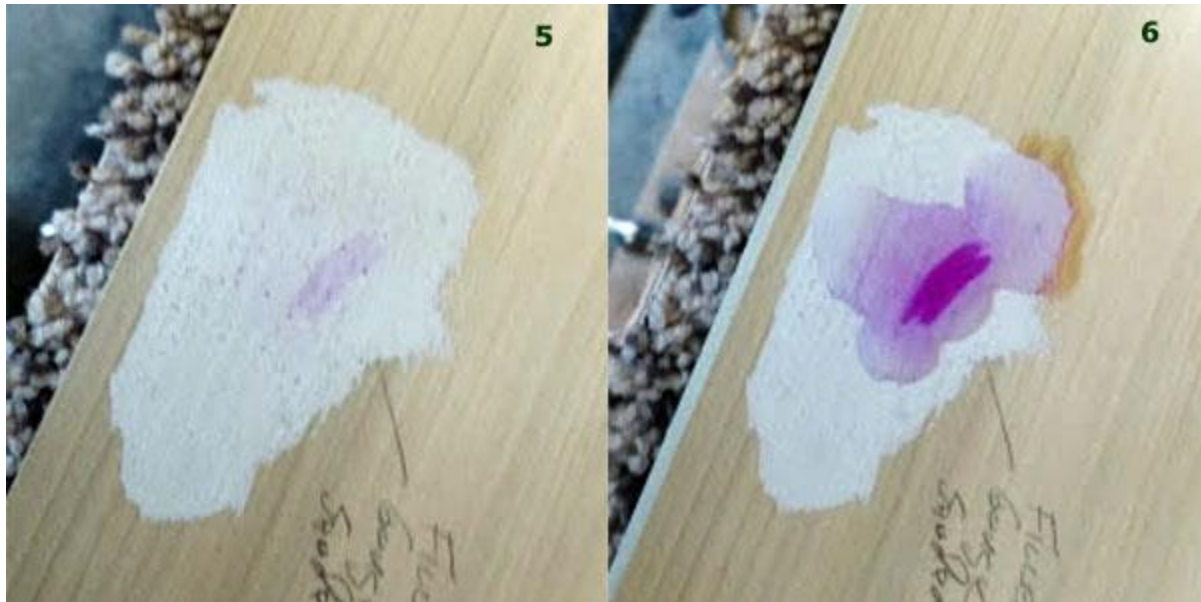
Looking again at my test board I saw that the stain had *somewhat* faded. (Compare photo #5 with photo #4 above.) The key word is "somewhat". The stain had not disappeared. It was still far too obvious to be ignored. I would not, for a moment, have even considered delivering this piece of custom furniture with so obvious a blemish in the finish. But what I want you to see is the small dots of color that surround the defect. It is this pattern of colored dots that I now see in my finish. Even though the filler was physically removed the contamination remained. Yes, the offending filler was replaced with Famowood, sanded,

and a new coat of milk paint applied. But there was still enough of the Minwax Color-Changing Wood Filler sanding debris left on the surface to result in an unacceptable finish. The "ghost" of Minwax past is still with me.

One final observation, if I may. Look again at photos #5 and #6. Photo #6 is the result of an *I-wonder-what-will-happen-if* on my part. Specifically, what happens if this stuff gets wet in daily use? Not possible you say. Not so fast. Many finishes are "water-proof"; liquid water cannot penetrate the finish film. But no commonly used finish is "moisture-proof"; water-vapor can and does pass through the finish film. It moves in both directions. This is major reason why wood continues to move. It expands and contracts across the grain with changes in seasonal and local humidity. What you see in photo #6 is the result of a few drops of water applied to the finish in photo #5.

At this point I surrendered to the inevitable and physically removed the *Minwax Color-Changing Wood Filler* by carving the filler out of the defects. This, of course, left an even larger defect than I had filled the first time around. I then filled with Famowood, sanded, and applied the milk paint. Problem solved, right? Well, almost... There was still the matter of the filler dust left from the previous sanding. The stain was reduced but still not gone. Anywhere that sanding dust from the *Color-Changing Wood Filler* remained the stain again rose its ugly head.

Once again, I removed the damaged milk paint. This time, however, I thoroughly wiped the area down with acetone hoping that the offending chemical in the Minwax filler would be neutralized. It worked. After the acetone completely evaporated, I was able to apply the milk paint with no stain caused by the Minwax *Color-Changing Wood Filler*.
